NASA CR-132519

EVALUATION OF A METAL FUSELAGE FRAME SELECTIVELY REINFORCED WITH FILAMENTARY COMPOSITES FOR SPACE SHUTTLE APPLICATION

FINAL REPORT

Boeing Aerospace Company

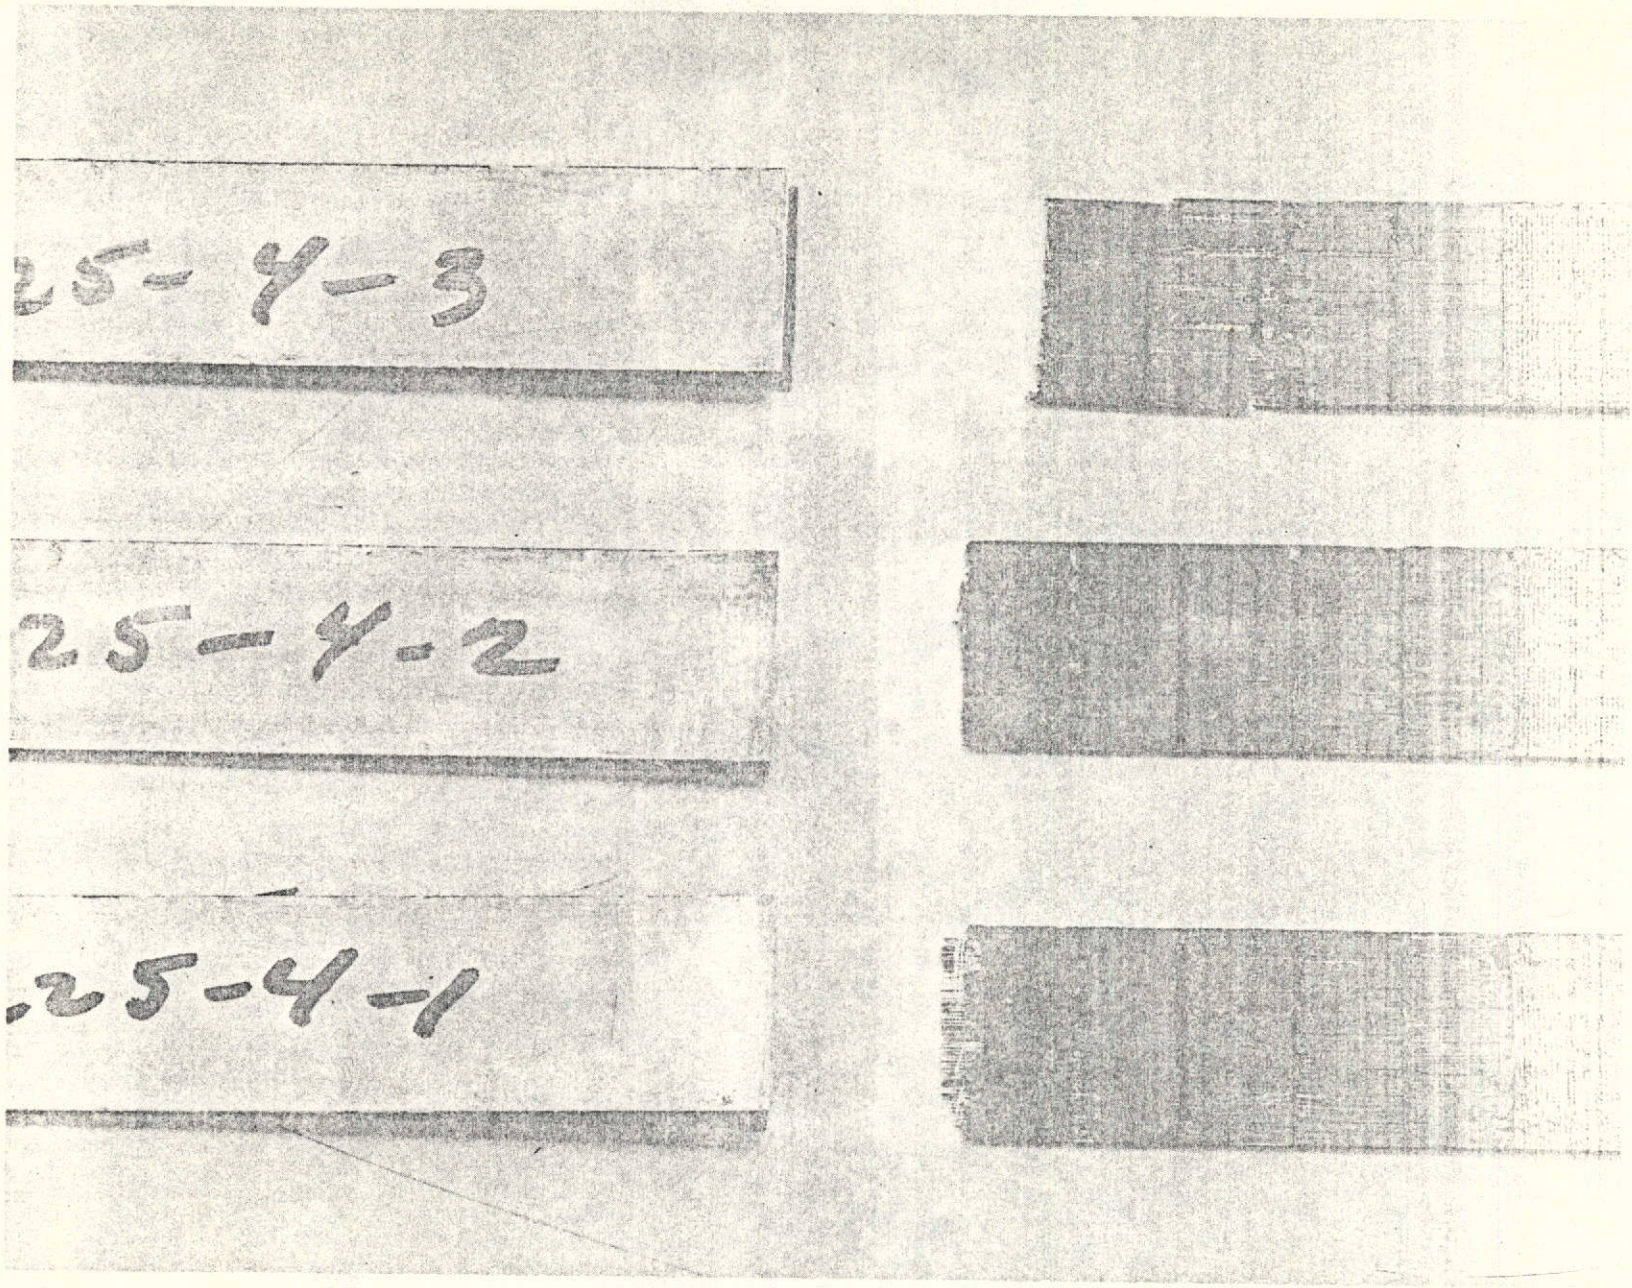
Figure 4.0-3: Load Transfer Speciments—Typical Failed Joint Areas

The initial specimens tested were used to evaluate four processes for preparing titanium for bonding. Included in this group were phosphate fluoride and Pasa Gel treatments widely used for polyimide bonding and an alumina blast with either a methyl ethyl ketone (MEK) wipe or a silane rinse (Union Carbide A-1100). The specimens that included step fittings prepared by chemical cleaning followed by Pasa Jel or phosphate fluoride conversion coatings failed at lower fiber stress levels than those specimens that were abrasively cleaned. The chemically prepared specimens also exhibited a larger scatter than those prepared by alumina blasting. In the later group those processed with a silane rinse developed higher tensile properties. The alumina blast with a silane rinse was therefore selected as the process that would be used in the balance of the program. A summary of the test data developed in this evaluation is shown in Table 4.0-1. Figure 4.0-3 shows a close-up of typical failed areas.

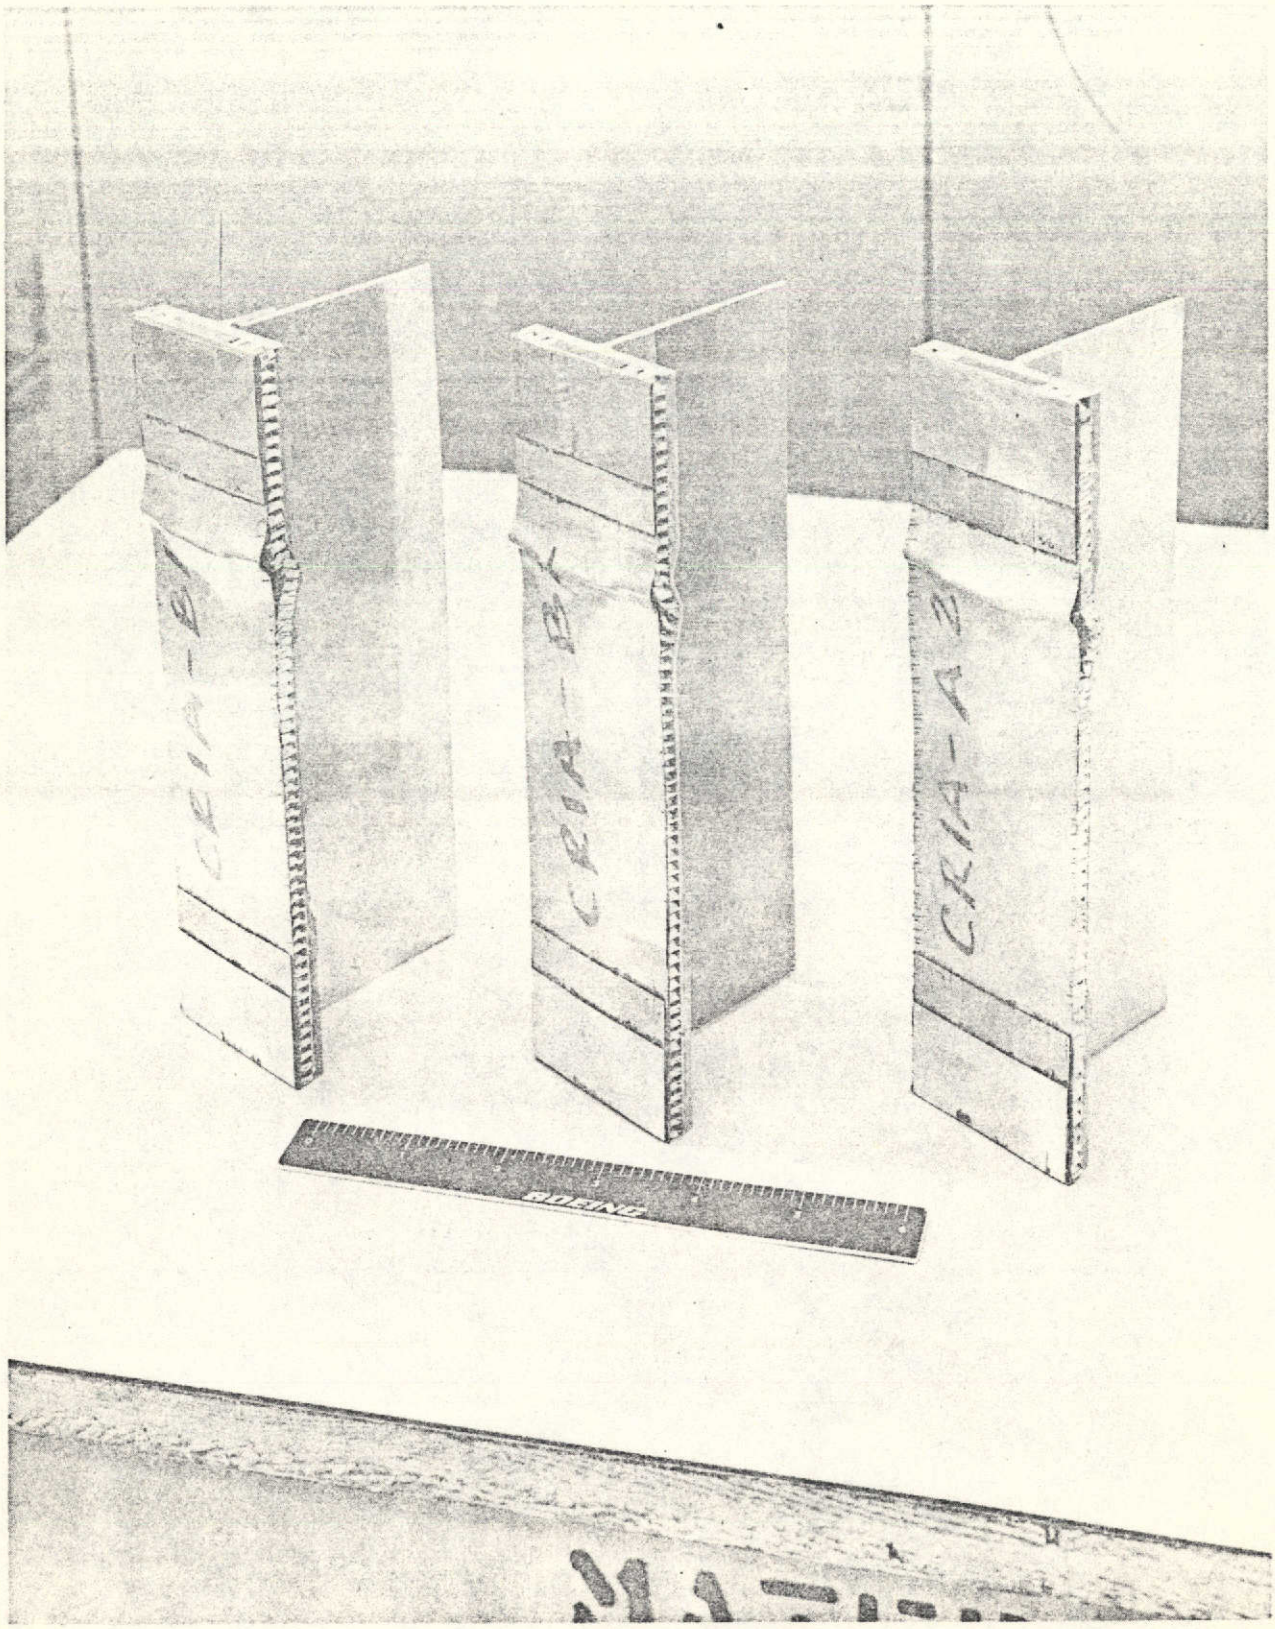
Figure 4.0-8: Failed Aluminum Chord Crippling Specimens – Boron/Epoxy

All of the chord element specimens tested developed strains at failure that exceeded their design requirements, except for the one of the "C" configuration specimens tested at temperature. A summary of these test results is shown in Tables 4.0-6 and -7. Typical failed crippling specimens are shown in Figure 4.0-8.

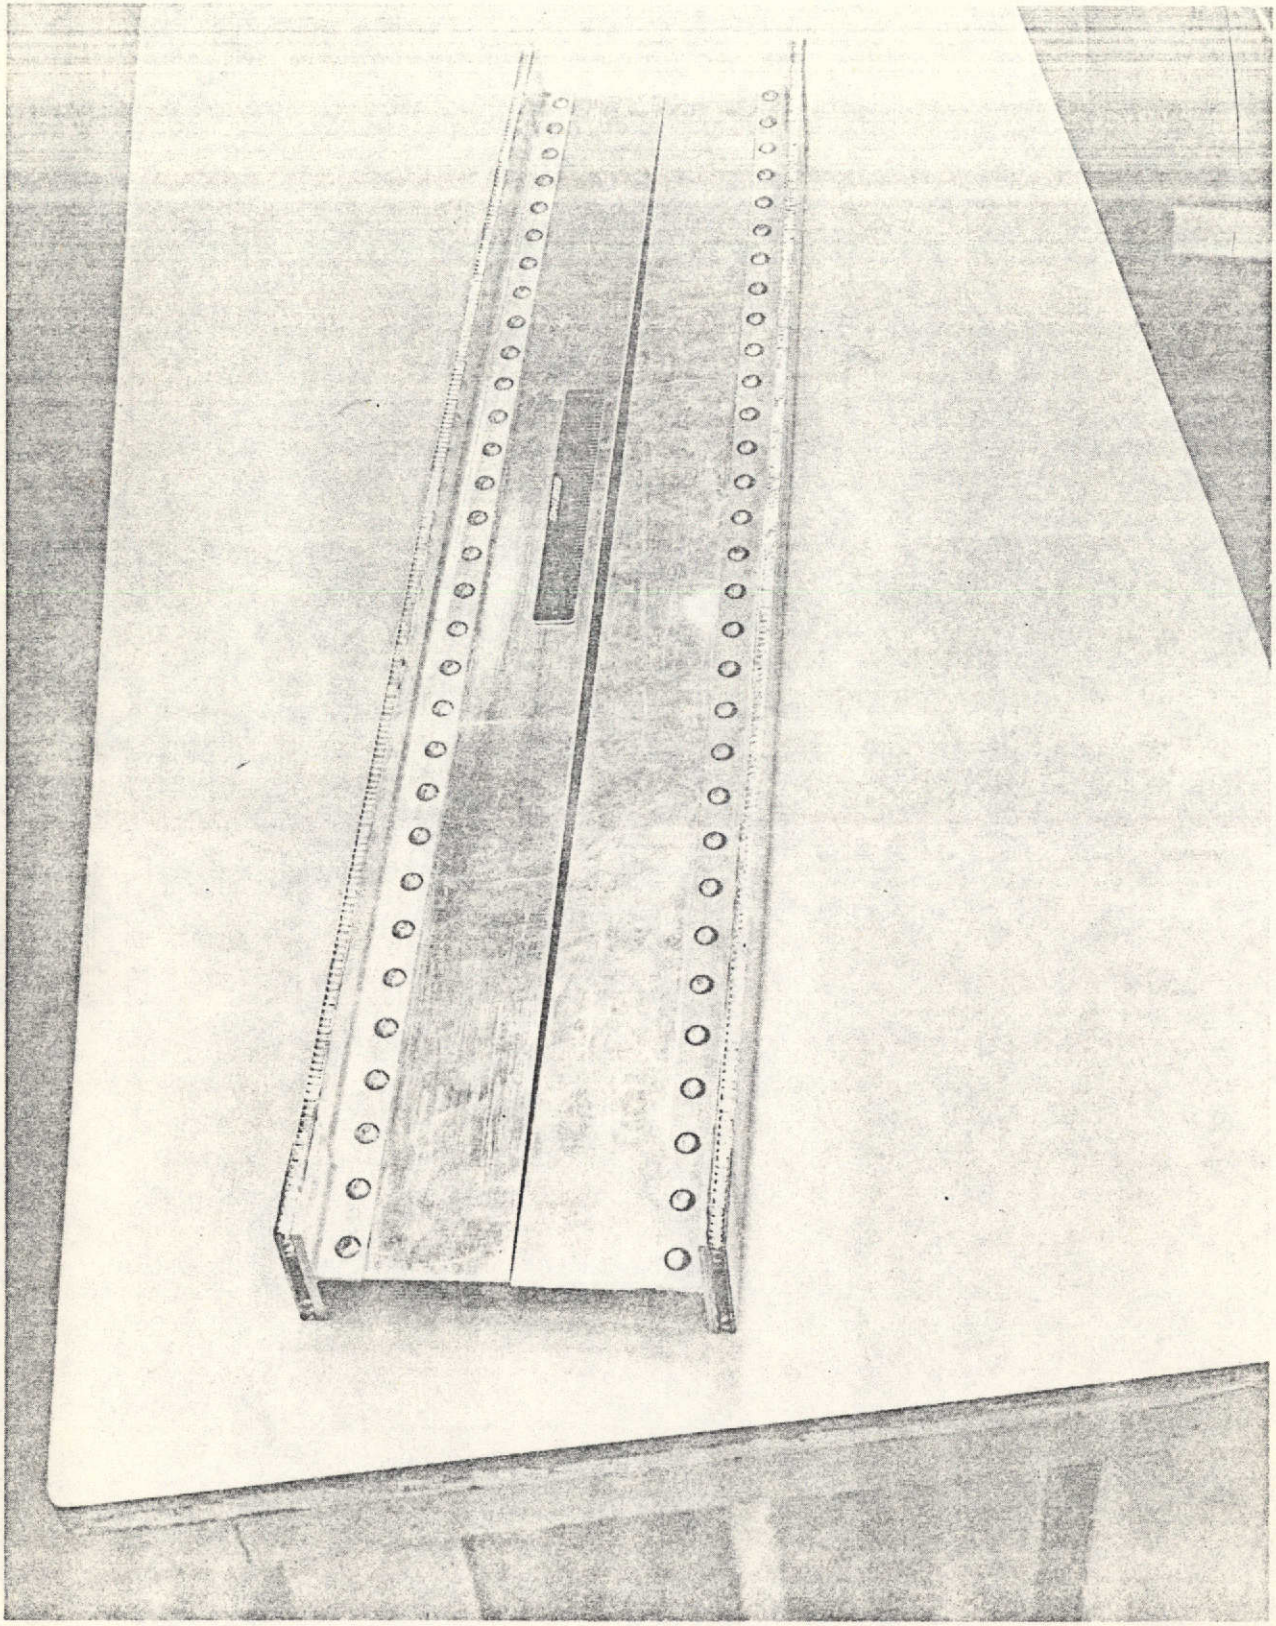
Figure 4.0-9: Column Elements Place Back-to-Back to Illustrate Degree of Thermal Distortion – Boron/Epoxy-Aluminum

Two column specimens assembled at 394°K (250°F) and two assembled at 450°K (350°F) were tested. They all developed strains at failure of approximately 5000μ which exceeded their design requirements. A summary of these tests is shown in Table 4.0-9. The column specimens developed a bow of (0.12) inches because of thermal stresses established during bonding. Figure 4.0-9 shows two of these specimens back-to-back to illustrate the degree of distortion.

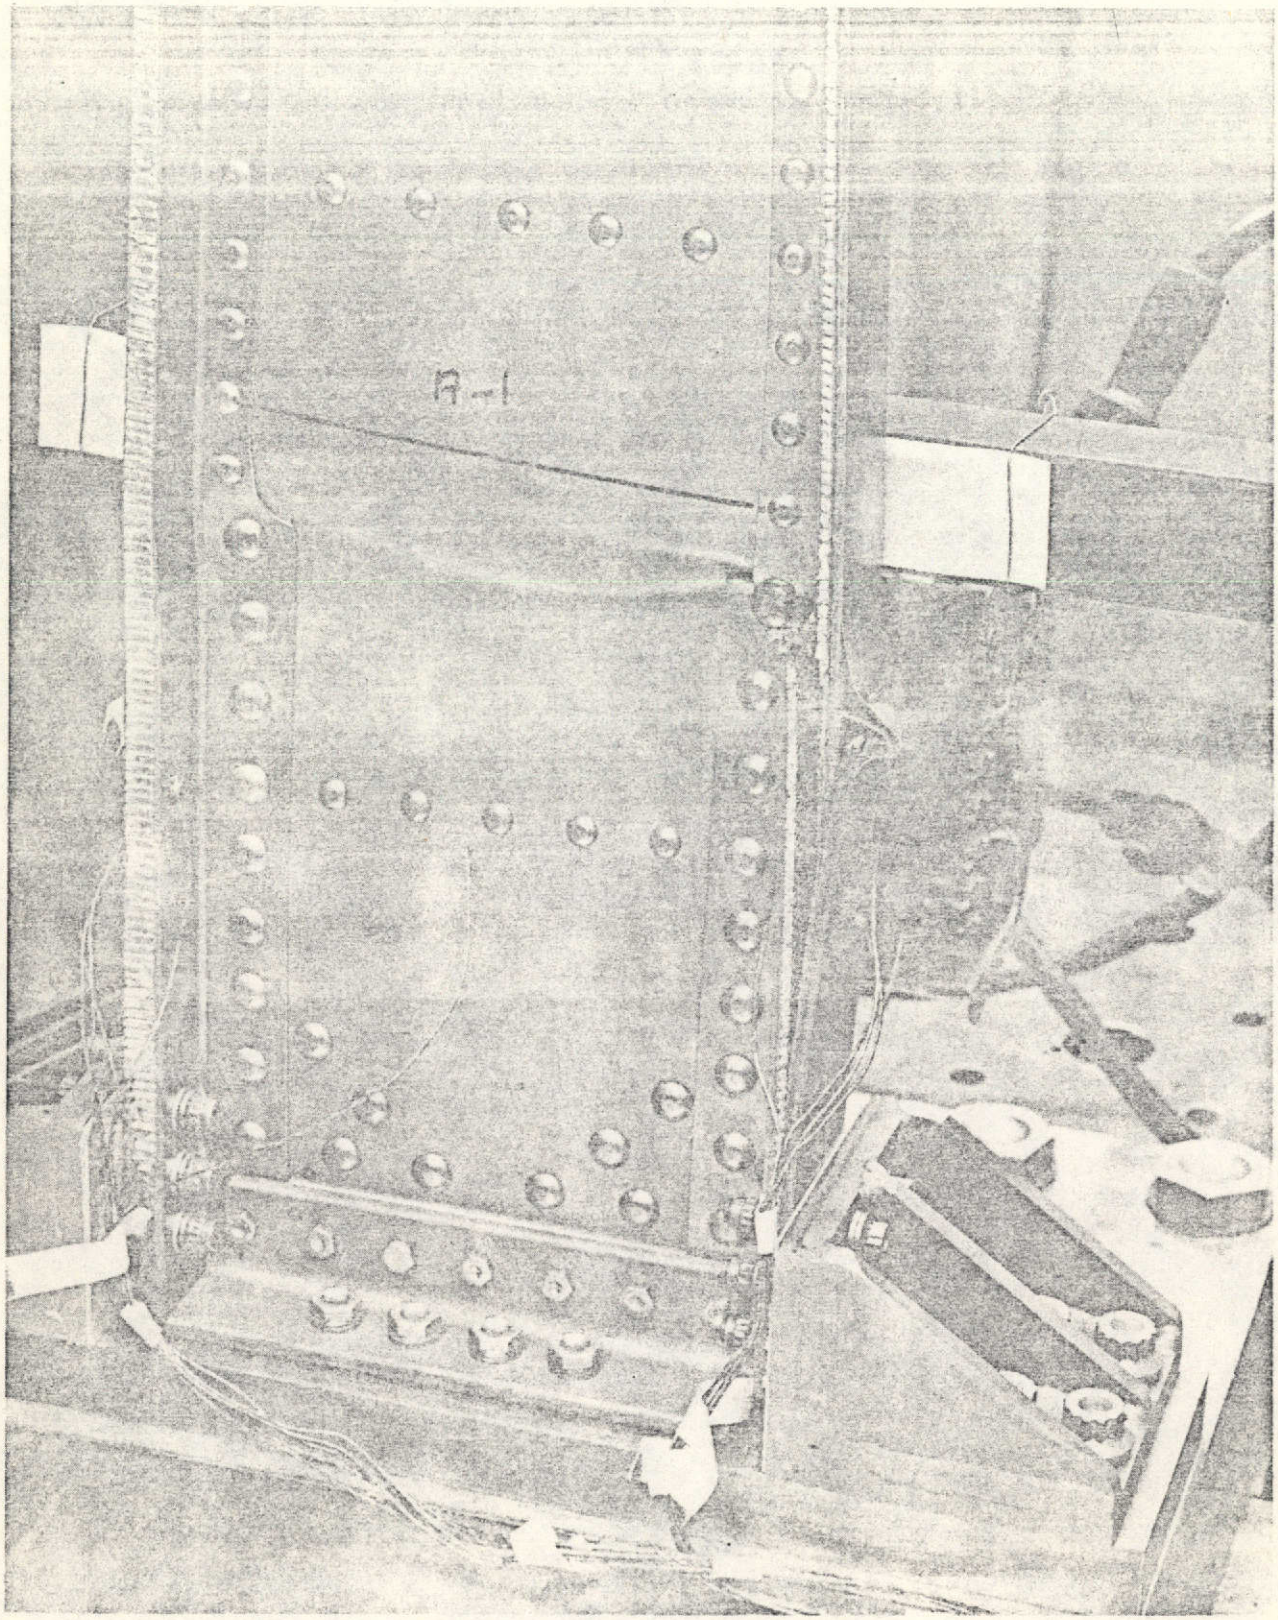
Figure 4.0-14: Failed Curved Beam No. 3

The first two beams failed prematurely during cycling due to a flaw caused by poor drilling procedures and not providing the proper lateral support during test. These problems were corrected and the next two beams attained their design requirements. One beam was cycled to limit load 400 times. It was then loaded to failure at room temperature. It failed at a load of 33,805N (7,600 pounds) which was 8.5% above design ultimate. The last beam was first loaded to limit load at room temperature. It was then loaded to failure with its lower critical portion heated to 464°K (375°F). This beam failed at a load of 17,792 N

(4,000 lbs.) which was 14% above its elevated temperature design requirement. A summary of the curved beam element tests is shown in Table 4.0-12. A typical beam failure is shown in Figure 4.0-14.

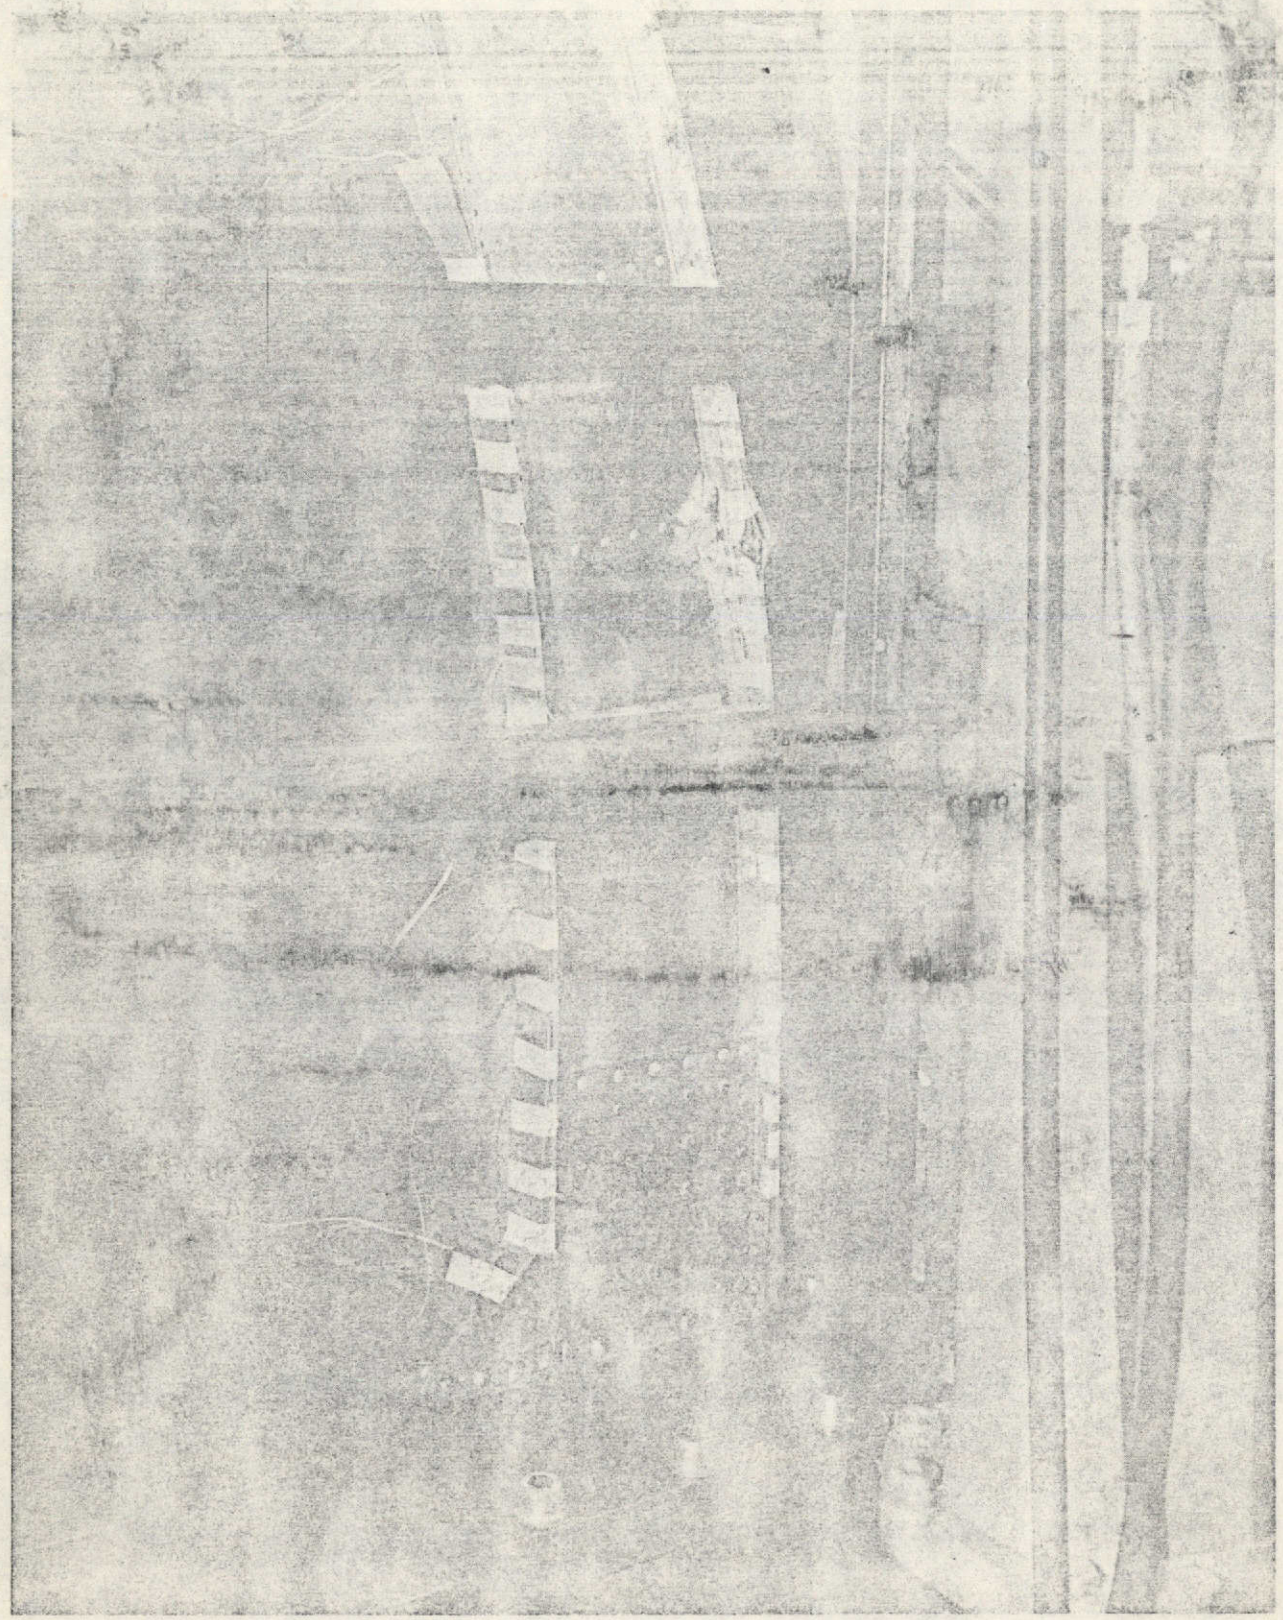
Figure 5.0-16: Eight-Foot Curved Beam—Elevator Temperature Test

was tested at 464°K (375°F). These beams were first loaded to limit at room temperature and then loaded to failure at elevated temperature.

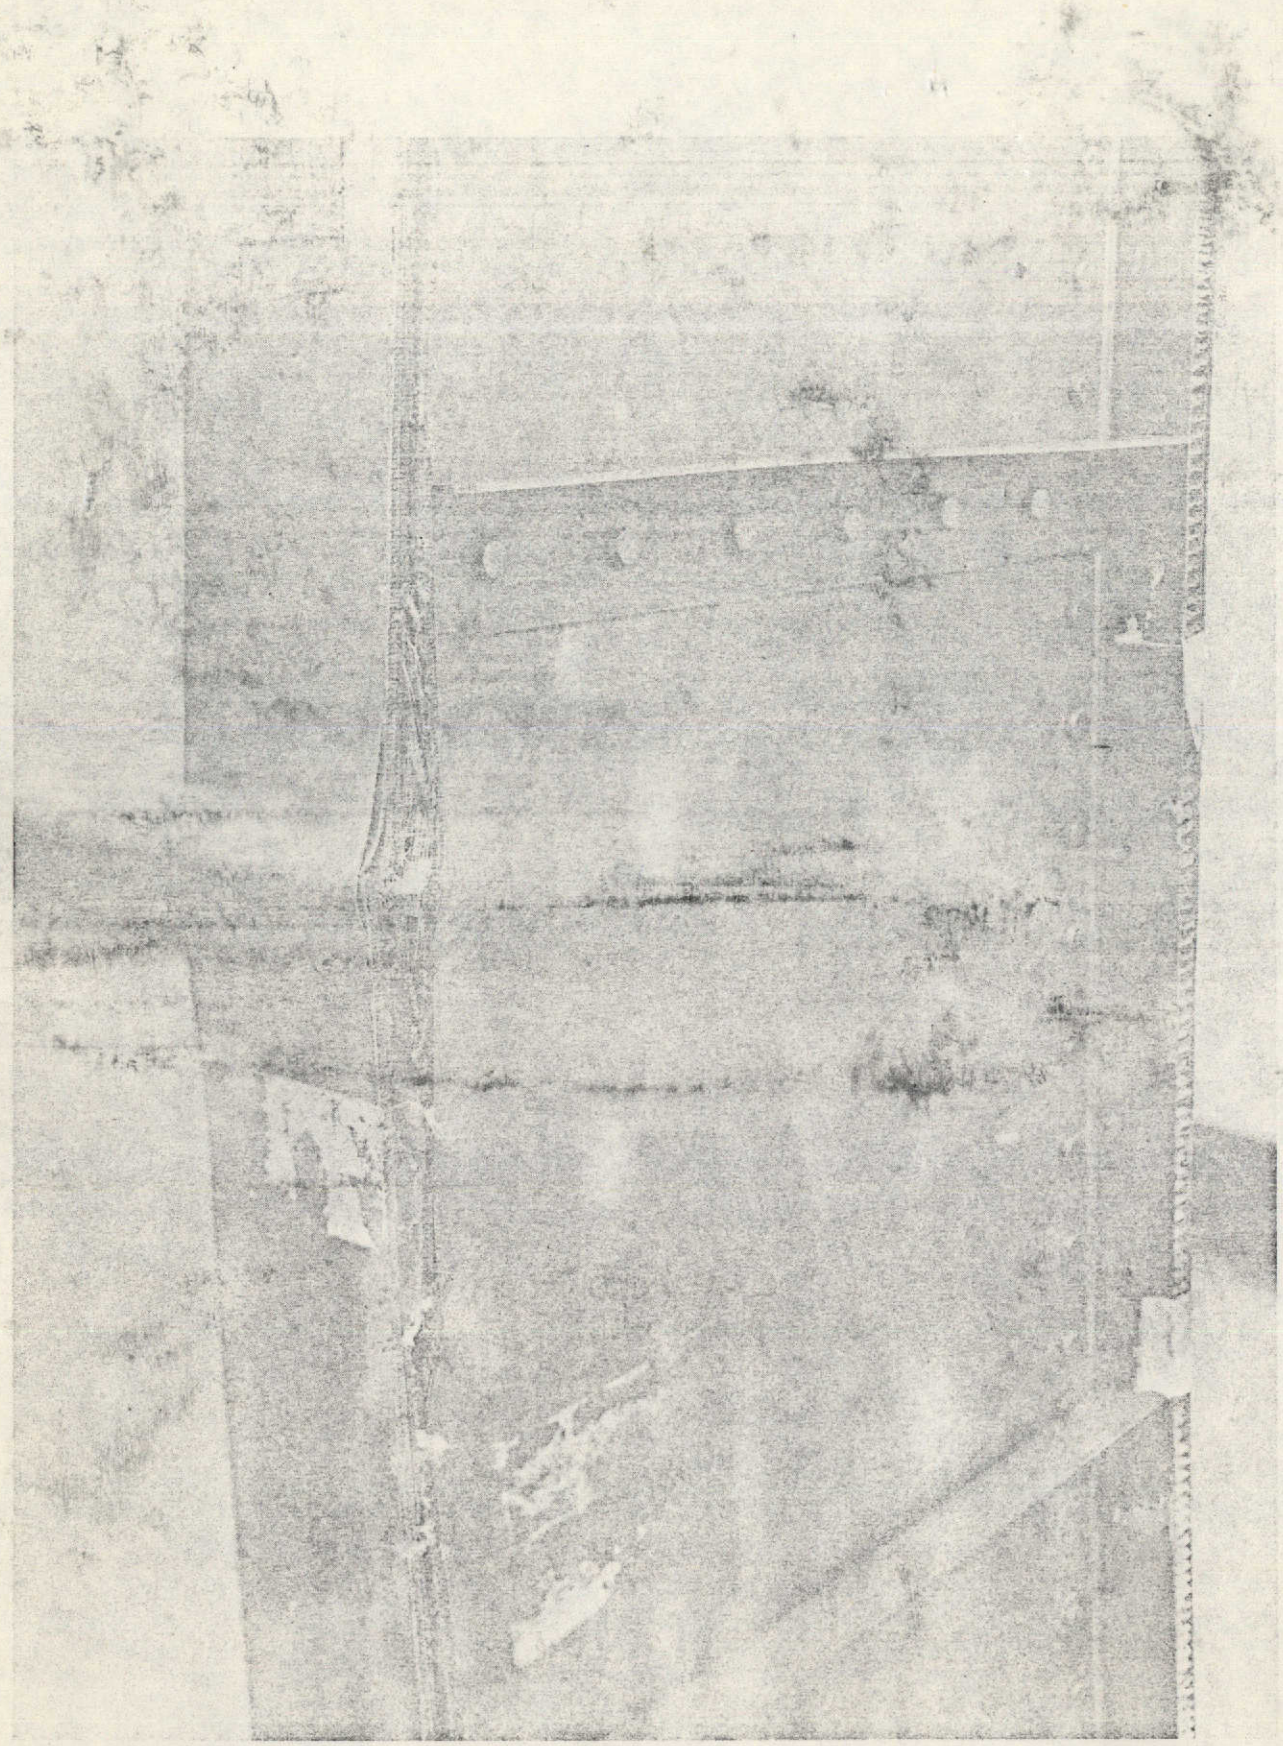
Figure 5.0-17: Close-Up of Boron/Epoxy/Aluminum Beam Failed at 394°K (250°F)

A summary of the 8-foot curved beam test results is shown in Table 5.0-2. A typical beam failure is shown in Figure 5.0-17. This failure occurred in the compression chord in a local crippling mode.

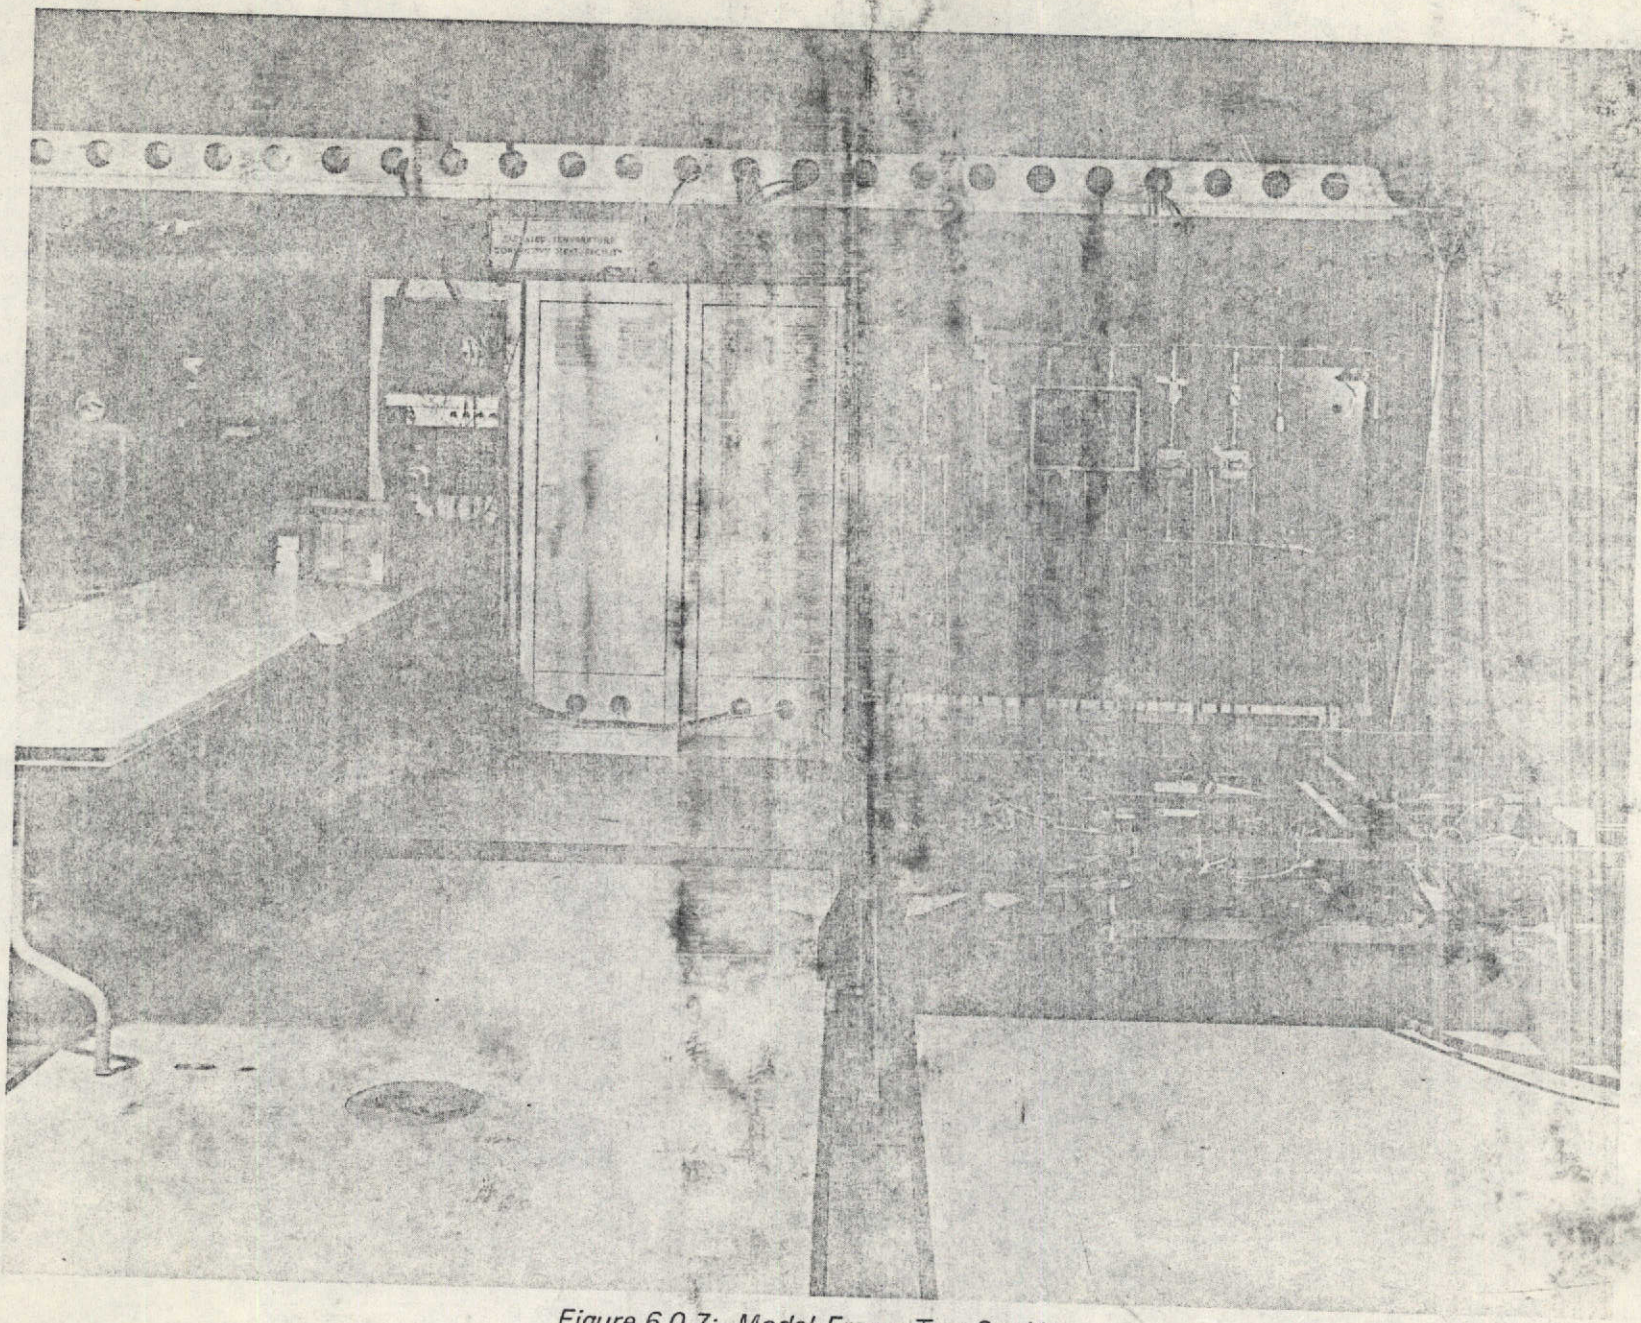
Figure 6.0-7: Model Frame Test Set-Up

The model was tested in a horizontal position as shown in Figure 6.0-7. After being installed in the test fixture, strain gage circuits were completed and balanced, the EDI's were connected and the hydraulic load cells were installed. Six hydraulic jacks were attached to the model at four locations as shown in Figure 6.0-8. Loads were programmed to these jacks in a manner which simulated vehicle flight conditions. An SDS 910 computer was used to program all loads through the controllers. Data was recorded on tape and also was presented in real time on TV screens at the test site. This permitted the critical data to be plotted and monitored as testing progressed. Three programmed load tests were performed. Load was applied in increments. Strain gage, EDI, and load data was recorded at each increment.

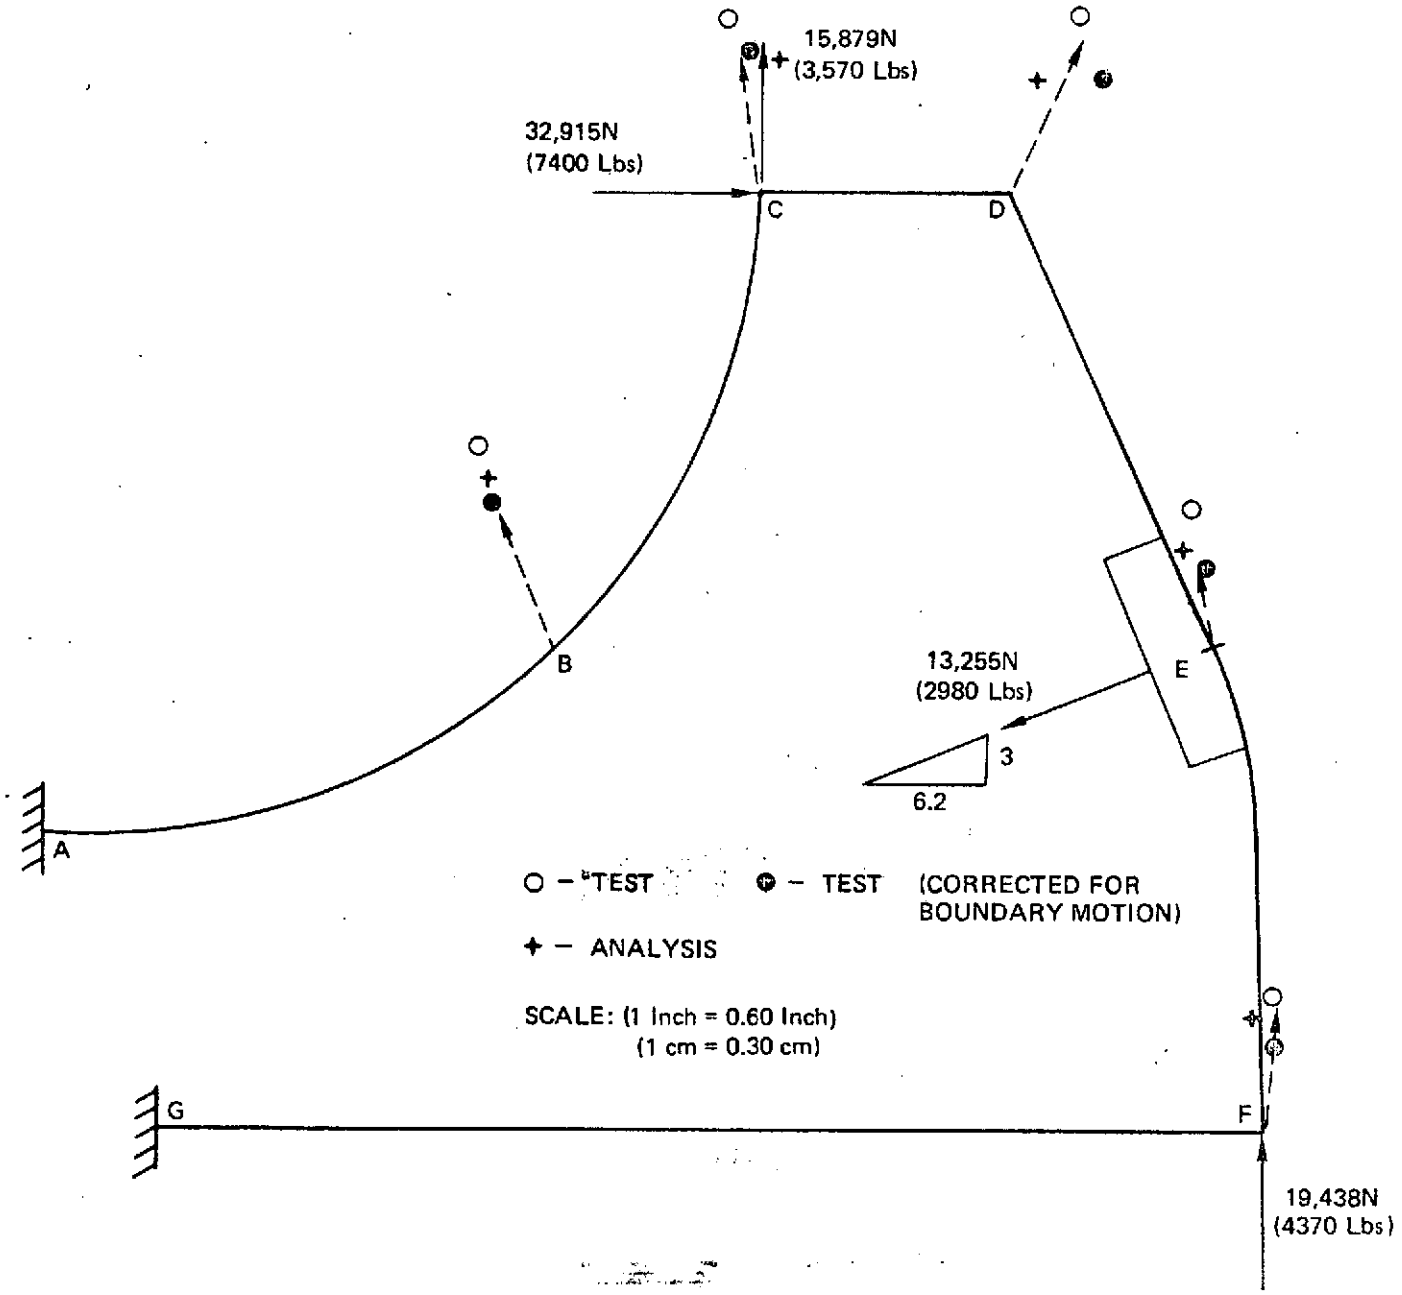
Figure 6.0-11: Frame Displacements — Orbiter Ignition - Limit Load

The strain gage data and frame deflections obtained during the frame tests were compared to the theoretical predicted values obtained in the NASTRAN analysis. In general, excellent correlation data developed as shown for the Orbiter Ignition Limit Load condition in Figures 6.0-11 and -12. Maximum deflection deviation was less than 0.20 inches and strain deviation less than 8%.

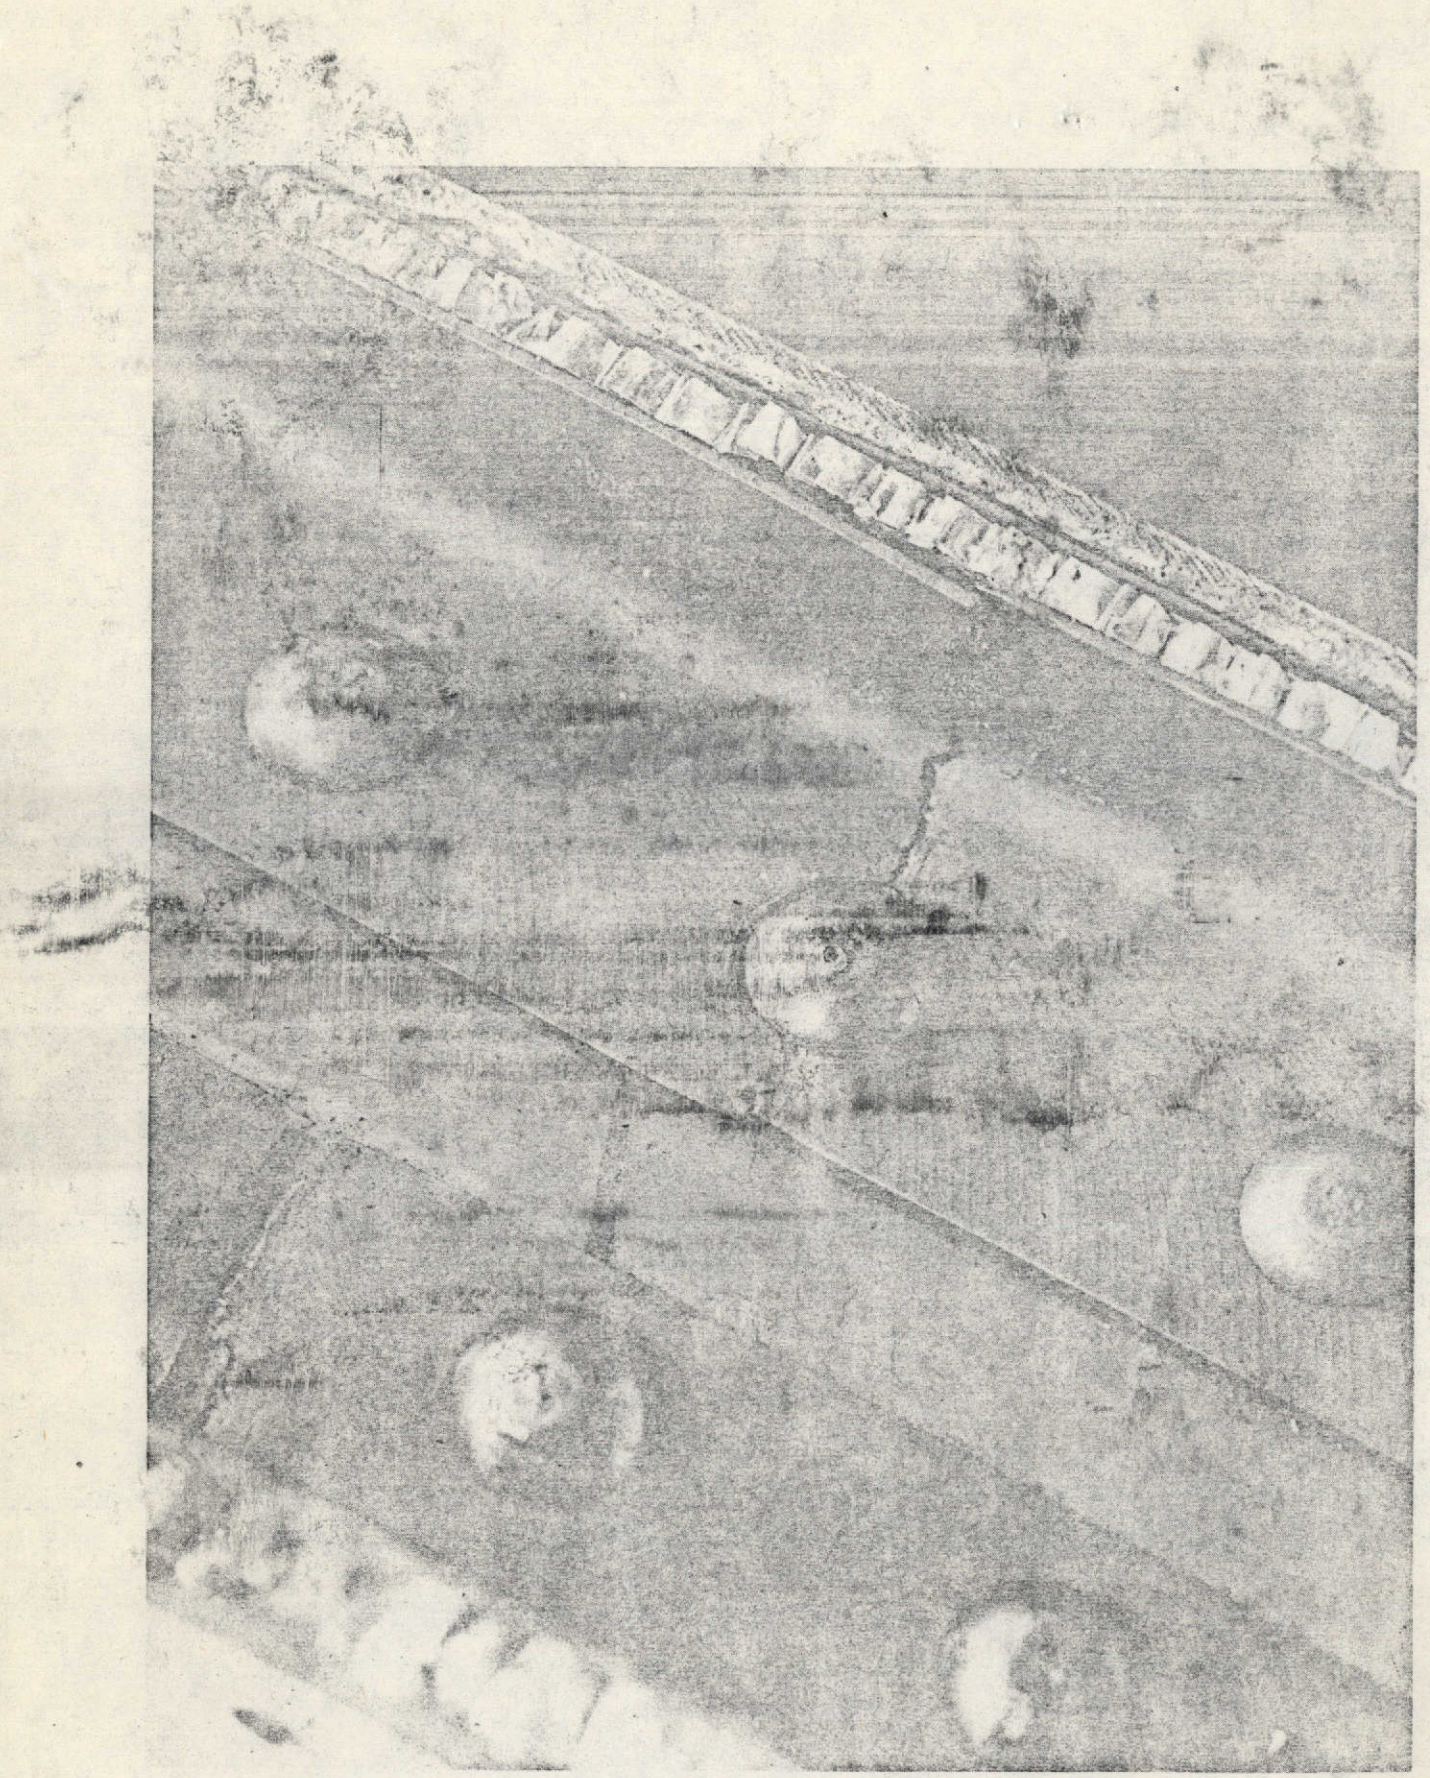
Figure 6.0-13: Model Frame Failure

The model scale frame was loaded to failure using the combination of loads simulating the orbiter ignition condition. Failure occurred at 8% above the design ultimate. The maximum chord strains developed during test at design ultimate were within 10% of the strain levels predicted by the NASTRAN analysis and at failure the maximum strains were approximately 3% above the design tension allowable. The maximum strain and failure occured at the location which the analyses predicted as the critical area in the frame. A close-up of the failure is shown in Figure 6.0-13.
